TECHNICAL ASSISTANCE TEAM
SITE ASSESSMENT
FINAL REPORT FOR:

G. E. APPARATUS SERVICE SHOP
SPOKANE, WASHINGTON

TDD T10-8810-015

REPORT PREPARED BY: ECOLOGY AND ENVIRONMENT, INC.
PROJECT MANAGER: MICHAEL G. BRAY
DATE: APRIL 1989

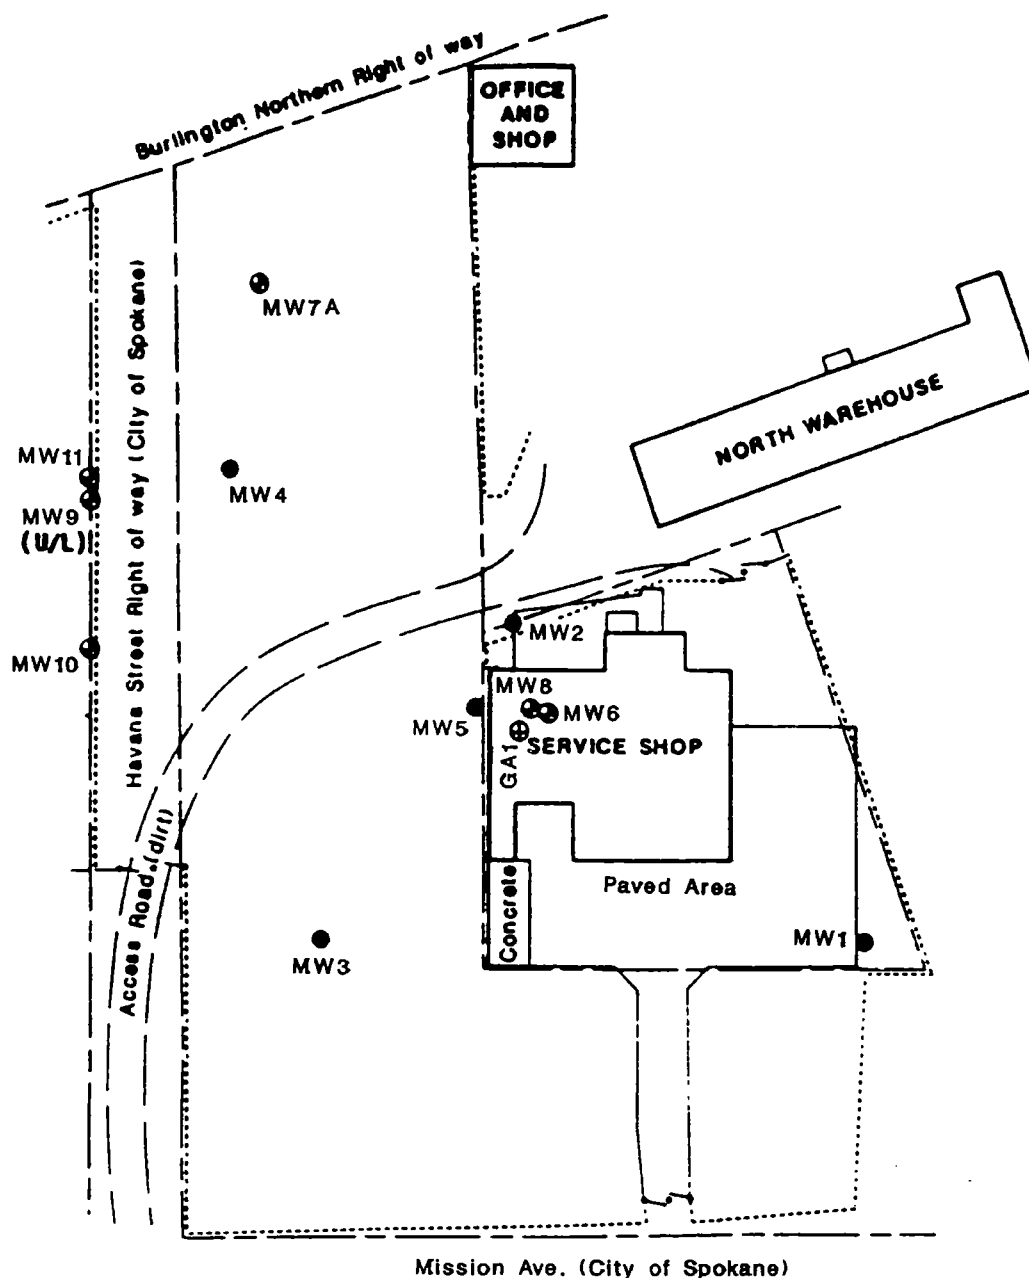
FIGURE 4 LOCATION OF EXPLORATORY BORINGS AND MONITORING WELLS

Contaminant releases from the west dry well have impacted the Spokane Valley - Rathdrum Prairie Aquifer. Comparisons of contaminant concentrations found in water samples collected from monitoring wells positioned directly below and downgradient of the west dry well to upgradient analytical results have verified the west dry well as a point source of contamination (see Figure 4 and Table 2) (Golder 1988).

PCBs were detected in groundwater samples collected from screened intervals at 60 to 75 feet b.g.s. in monitoring wells MW-2, MW-4, MW-5, MW-8, and MW-11 (see Figure 4 and Table 2). Analytical results of the groundwater samples indicate the highest PCB concentrations were found at MW-5 at 3.6 ug/l. PCB may also be present in the groundwater samples collected at MW-10 due to the detection of PCB congeners in the samples. PCB congeners were also detected in groundwater samples from MW-9L (screened interval 102 to 117 feet b.g.s.) and MW-9U (screened interval 148 to 158 feet b.g.s.) (Golder 1988; Metro 1987; York 1987).

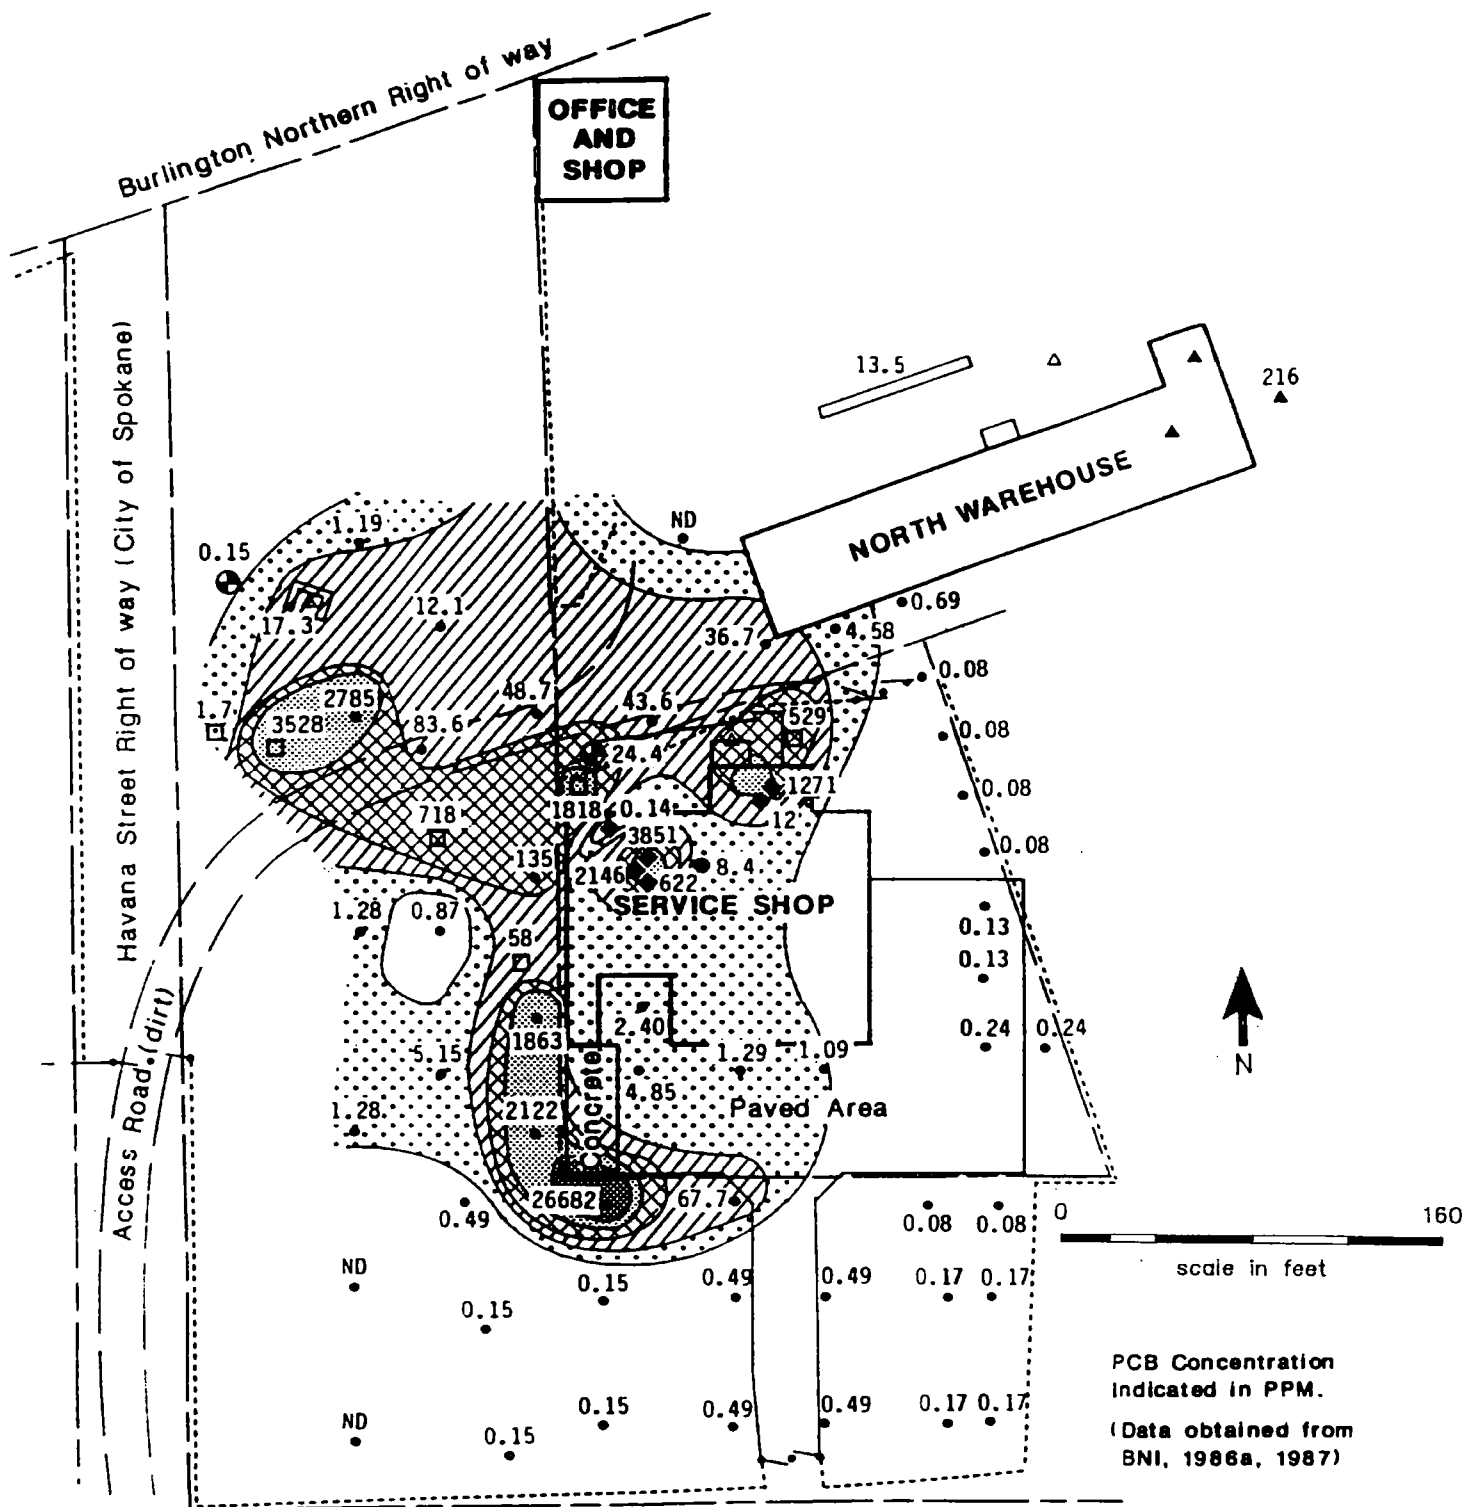
FIGURE 5
DISTRIBUTION OF MAXIMUM PCB CONC. IN NEAR SURFACE SOILS, PHASE 1 & 2 RESULTS
G.E. APPARATUS SERVICE SHOP
Spokane, WA

Analytical results of surface and near-surface soil samples indicate the PCB soil contamination on site is primarily located along the west side of the former Service Shop (see Figure 5). Sample results also show the PCB contamination extends along the northern portion of the building and along the southern edge of the paved/concreted area on the south side of the building. The sample results also show the area located south and west of a concrete pad (SW of the Service Shop) contained the highest concentration of PCBs in the soil (up to 26,682 mg/kg). This area was used as a transformer storage area.

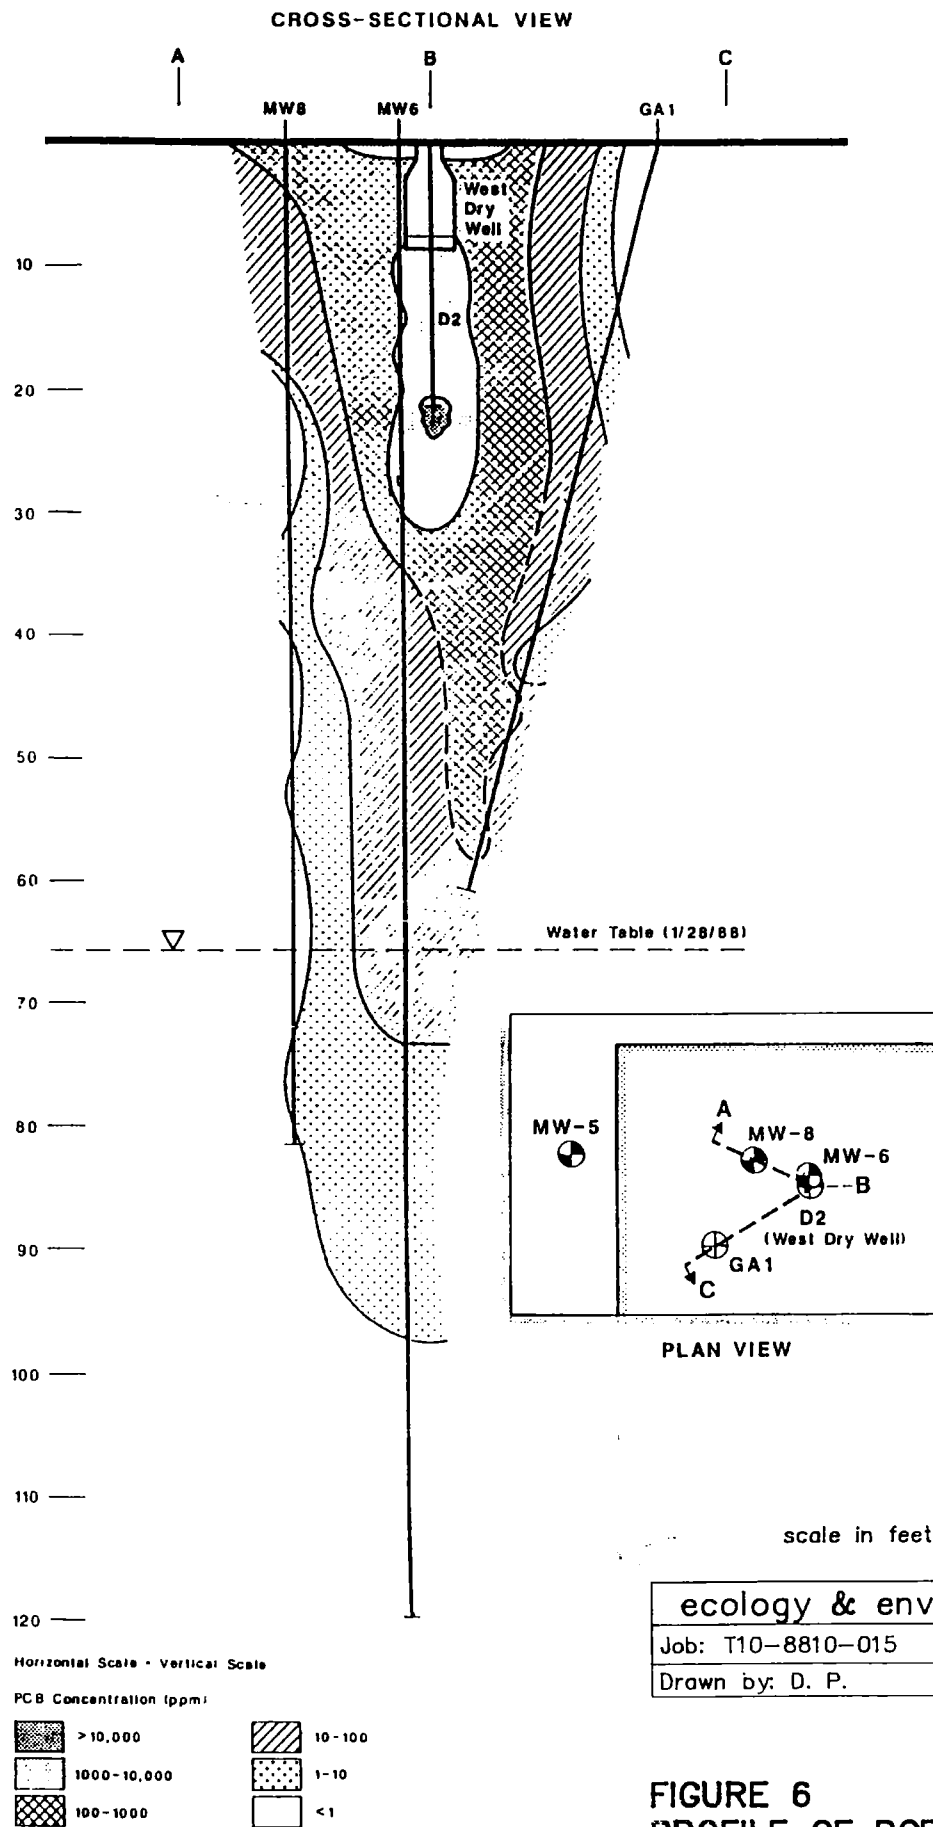
FIGURE 6
PROFILE OF PCB CONCENTRATION
IN WEST DRY WELL AREA
 G.E. APPARATUS SERVICE SHOP
 Spokane, WA

PCBs have been detected in soil samples collected directly from the west dry well. Borehole soil samples collected directly in the west dry well have shown PCBs at concentrations up to 21,400 mg/kg at 21 feet b.g.s. (Bechtel 1986a). Analytical results of soil samples collected from an adjacent borehole (GA-1) and from monitoring wells MW-6 and MW-8 have found PCBs at concentrations between 1000 to 10,000 mg/kg at depths down to 28 feet b.g.s.; 100 to 1,000 mg/kg at depths down to 60 feet b.g.s.; between 10 to 100 mg/kg at depths down to 84 feet b.g.s.; and between 1 to 10 mg/kg down to 103.5 feet b.g.s. (see Figure 6) (Golder 1988).
